MISCELLANEOUS PAPER S-73-13

# CONDITION SURVEY, WURTSMITH AIR FORCE BASE, MICHIGAN

P. J. Vedros, H. T. Thornton, Jr.

April 1973

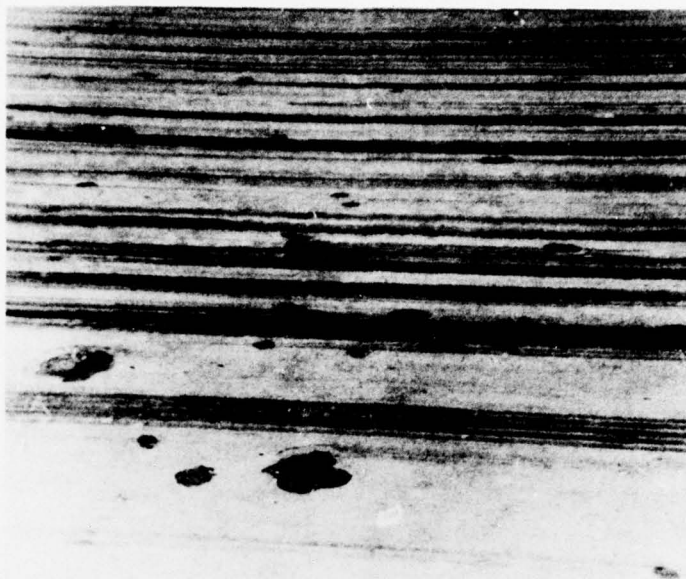
13. A detailed inspection (slab by slab) of the runway pavement indicated that it was in excellent structural condition. Eight slabs located in the 15-in.-thick pavement in the outside lane of the interior of the runway (feature R5D) contained the only major defects. However, as is shown in table 4, there were a considerable number of spalls and pop-outs, and some "D" cracking had occurred in the pavement surface. Every slab in the first 1000 ft of the southwest (06) end and almost every slab in the runway interior contained pop-outs (photos 1 and 2). An investigation of the spalling condition on the runway at WAFB was performed in 1966, and the results were published in the report referenced in paragraph 9a. There has been a progression in the number of spalls on the longitudinal joints since the 1966 investigation. The spalls and pop-outs have been repaired with patches of a latex material or an epoxy concrete. Since the patching on the runway has to be accomplished between aircraft operations, a fast setting epoxy patch is used. In some cases a poor patching job has resulted because of the rush. The repair of spalls and pop-outs is a costly, major maintenance problem at this airfield.

Photo 1. Pop-outs in interior of runway

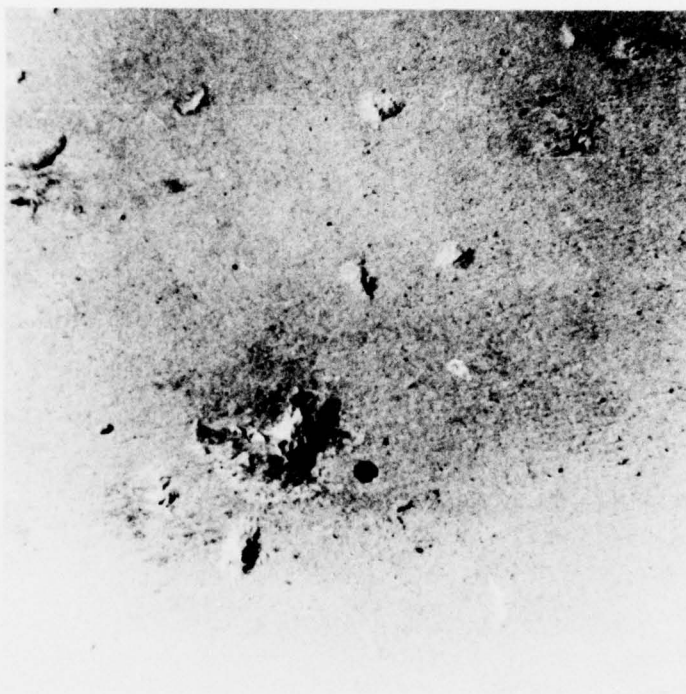
Photo 2. Pop-outs in traffic area D (outside edges of runway)

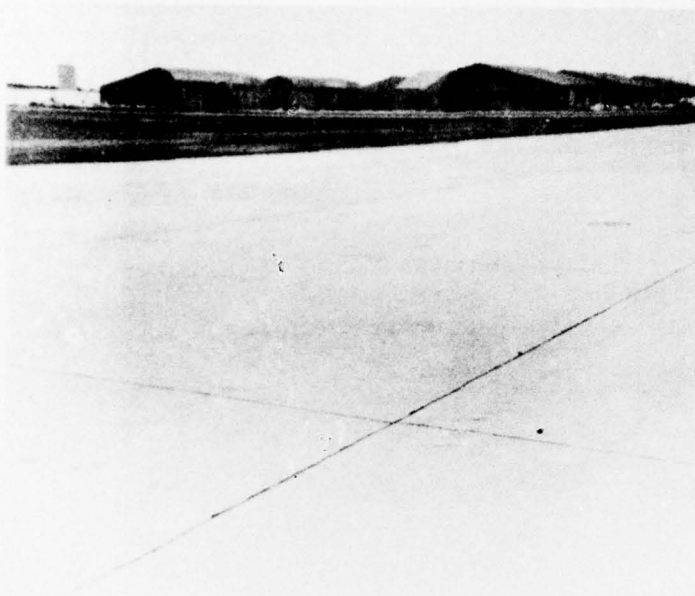
20. The remaining facilities were not selected for detailed inspection; however, a cursory inspection was made of the pavements. It was noted that taxiway K (the original NE-SW runway) was in excellent to poor condition. In 1970, a section of this taxiway (adjacent to taxiway J), which had an original pavement of 6 in. of PCC over 6 in. of soil cement, was replaced with 14 in. of PCC so that taxiway K could be used as a turnaround apron for unloading cargo. In 1971, a section of

Photo 3. New 14-in. PCC surface on taxiway K

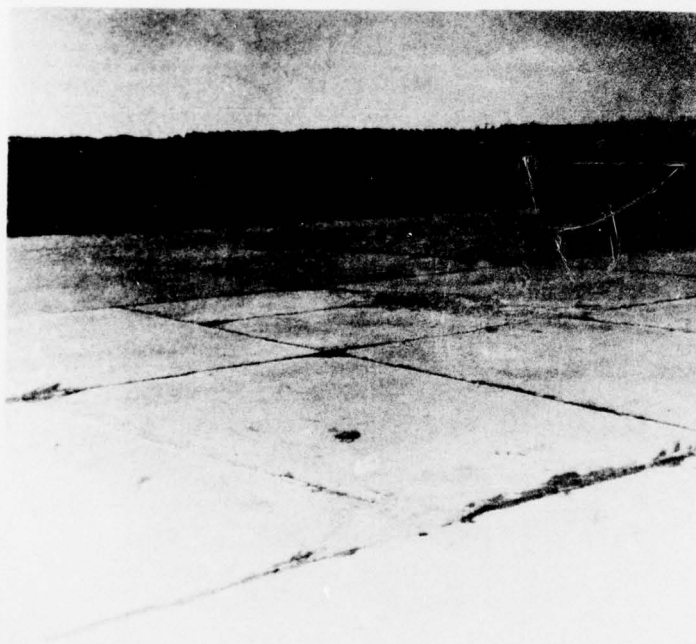
taxiway K (adjacent to taxiway G), which is used as a power check pad, was replaced with 9 in. of PCC, and a 10- by 10- by 3-ft reinforced concrete tiedown anchor was constructed. The new pavements were in excellent condition, and the original pavements, though not in use, were in poor condition (photos 3 and 4, respectively). The ADC operational apron was considered to be in good condition, even though a number of the slabs had major defects. In 1969, about 4500 sq yd of this apron area (originally 7 in. of PCC) was replaced with 9 in. of PCC (photo 5). Taxiway G (the old E-W runway), which received an asphaltic-concrete overlay on its center in 1967, was in fair condition. In the 1972 inspection, these pavements (taxiways G, J, and K) showed signs of cracking from overloads by fighters and transient aircraft.

Photo 4. Original pavement on taxiway K;  
condition rated poor
